An Accident Involving a Sharp-edged Quick-clip

From *Berg und Steigen*, 3, 2006, pg 12

Accident involving a sharp edged quick clip

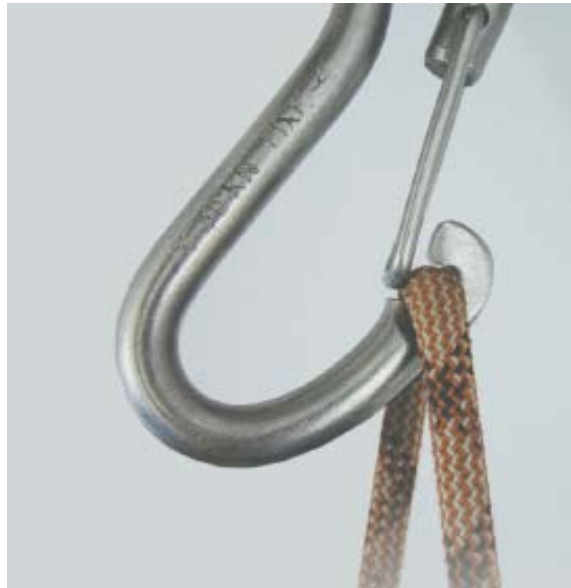
On June 2nd, 2006, a severe accident occurred at a Cologne, Germany, climbing gym. By placement of the rope in the quick clip and the subsequent lower-off, the rope was severed. The resulting investigation showed that the rope was cut by the sharp edge of the quick-clip. Further testing by the German Alpine Club Safety Committee suggests that this incident was not specific to a single instance of an unusually sharp edged quick-clip, but rather that this model of quick-clip is characterized by a similarly sharp edge. In the accident, the rope was not correctly placed in the quick-clips; instead, the rope was inadvertently placed in the notch in the nose of the quick-clip where it was held in place by the wire-gate. The quick-clip geometry and the size of the quick-clip nose caused the weighted rope to run through the quick-clip nose-notch. The sharp edges of the nose-notch finally led to the severing of the rope. (See photo.) We ask all climbing establishments to check quick-clips manufactured by Fixe. Should the quick-clips exhibit sharp edges and the nose permit the constraint of rope in the nose notch, we recommend replacing the quick-clips, or at the very least, rounding the sharp edges. We ask climbers to pay careful attention when clipping to insure that the rope lies correctly in the quick-clip and is not caught between the gate and the nose-notch as shown in the photo. **Chris Semmel, German Alpine Club Safety Committee.**

The opinion of the Austrian Alpine Club: For many years, we have offered this model of steel quick-clip from Fixe as it is especially suited for lowering off of half rope-length pitches. The unfortunate accident described above is to our knowledge unique. In part due to the freak nature of the incident and in part due to the situation, which involved a user error that is easily recognized as incorrect usage even by a novice climber, no recall is recommended. We will continue to offer this quick-clip. It is reasonable for the climber to be responsible for the correct placement the rope in quick-clips before lowering. We recommend that the manufacturer remedy this flaw in future production. **Austrian Alpine Club, Department of Mountain Sports**
